YORKSHIRE DALES NATIONAL PARK AUTHORITY

Yoredale
Bainbridge
Leyburn
North Yorkshire
DL8 3EL
Tel: 0870 1 666333
Fax: 01969 652399
E-mail: planning@yorkshiredales.org.uk

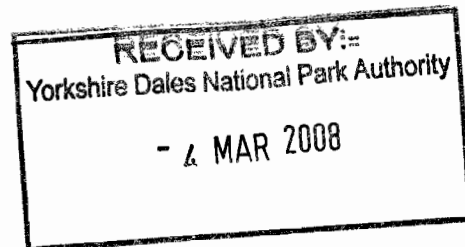
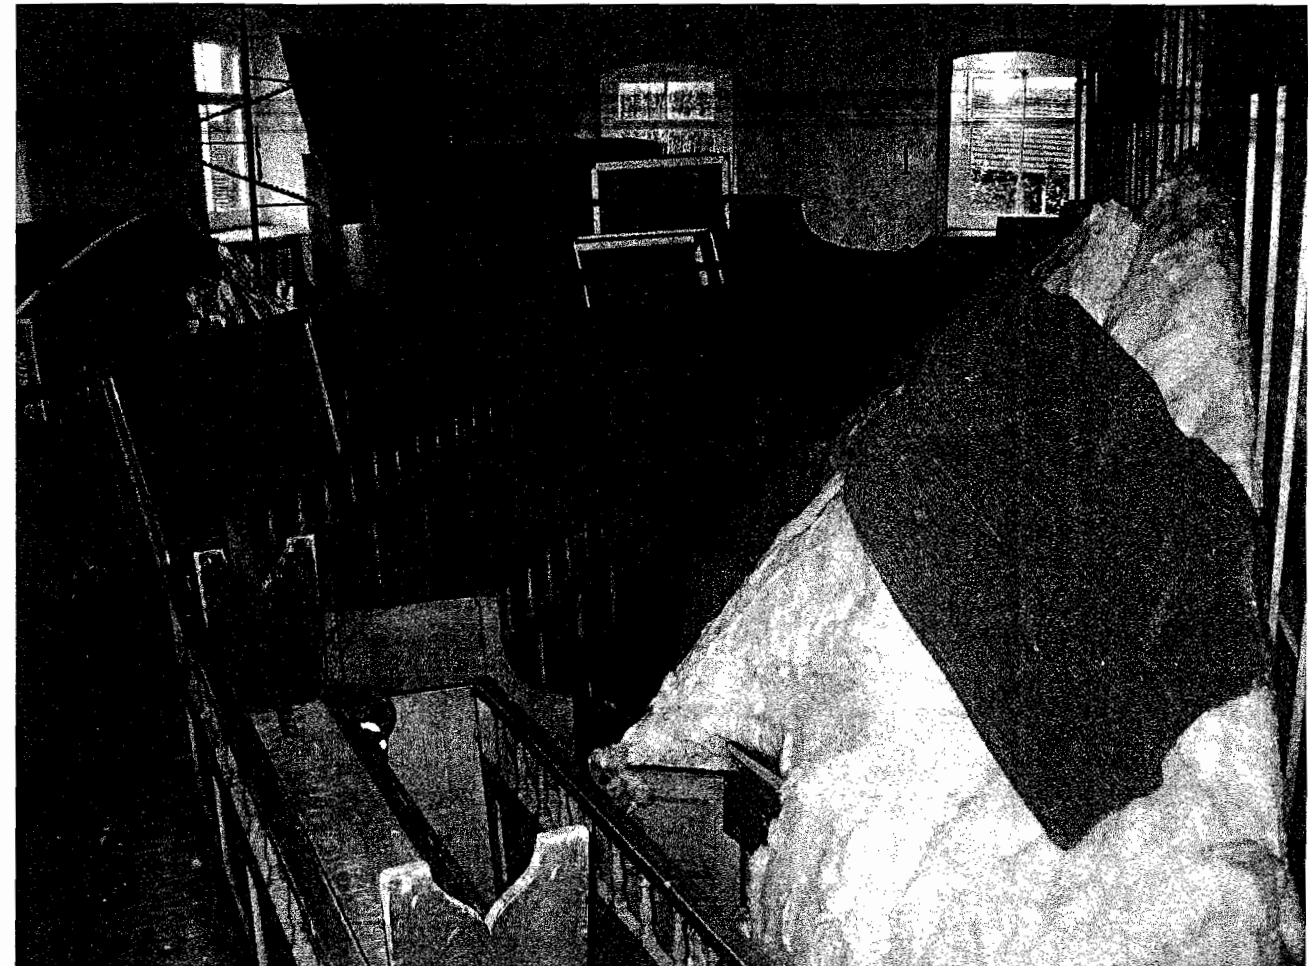
Gallery level above.

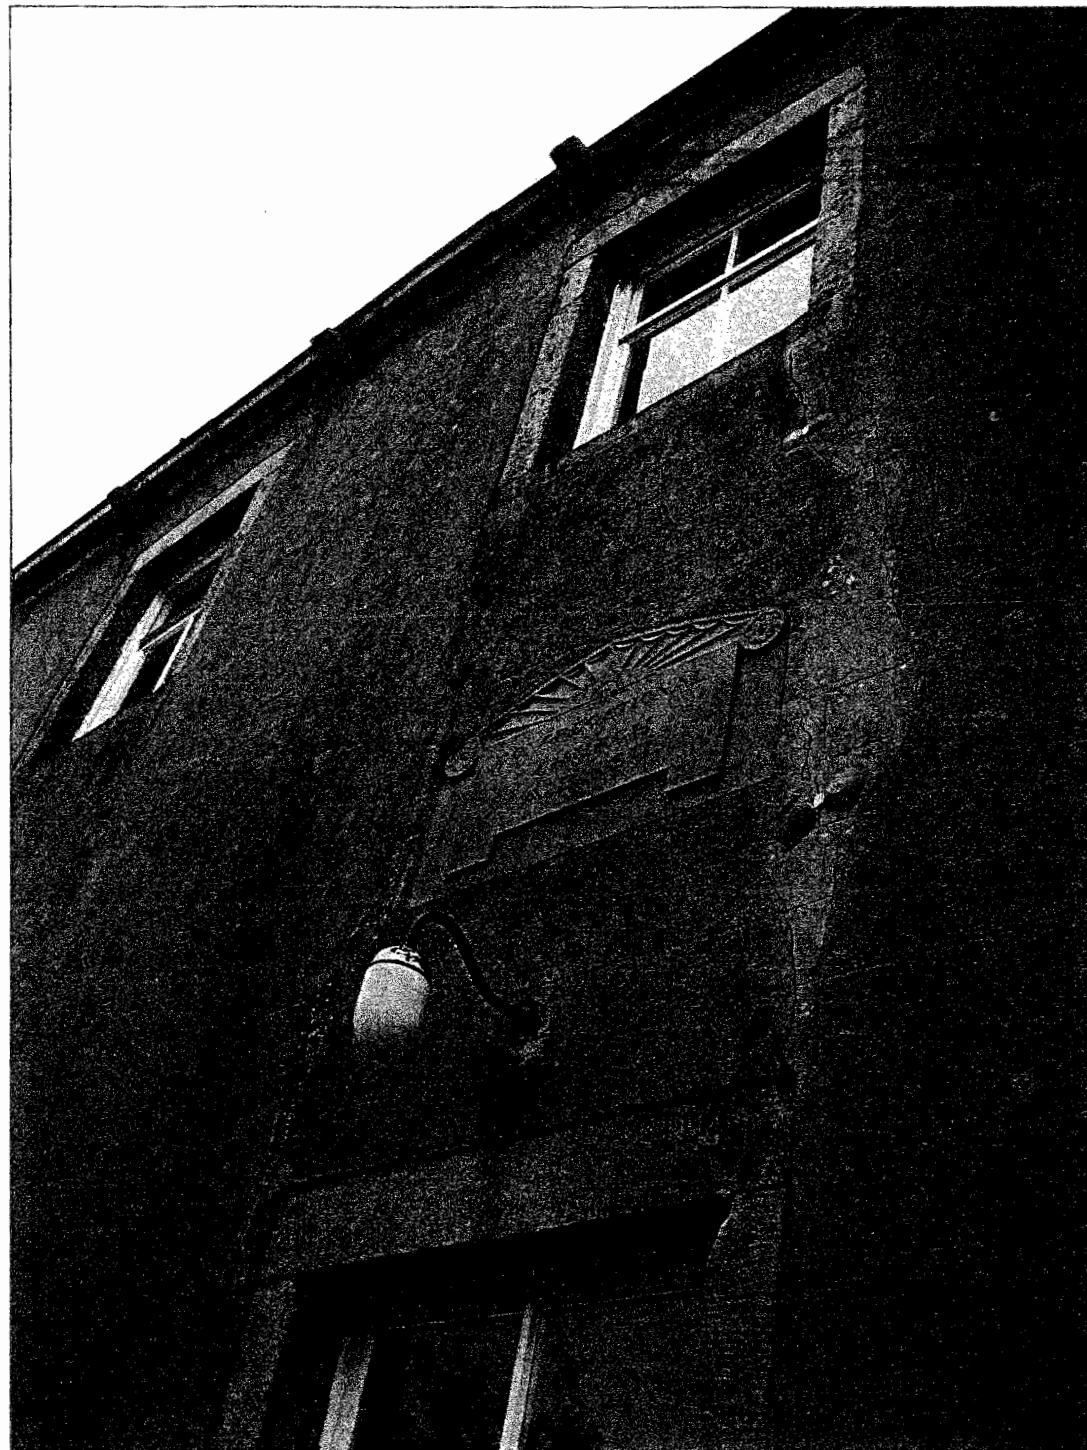
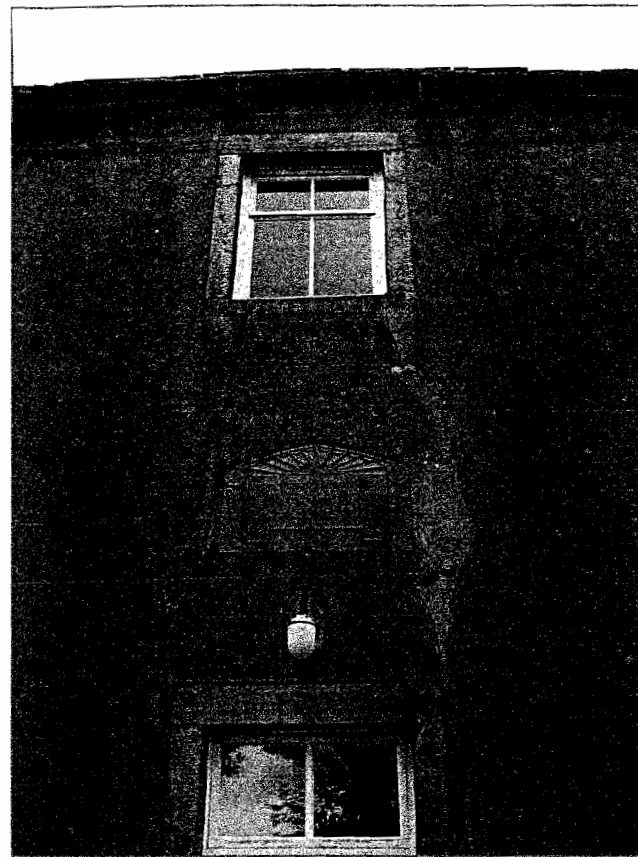
Cracks through external wall.

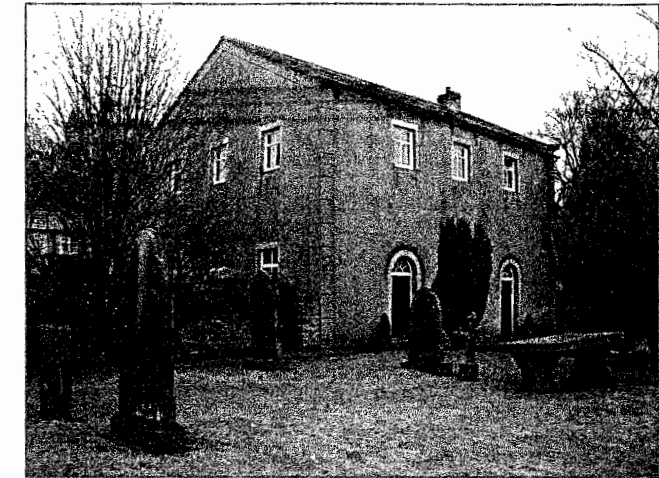
Chapel elevation (west) indicating wall bowing following outward roof thrust

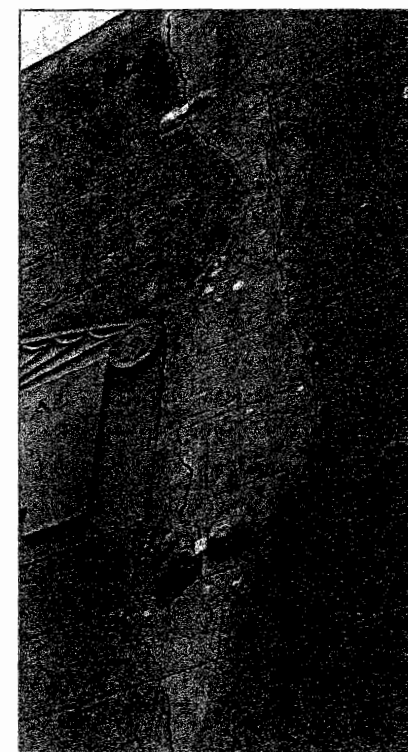
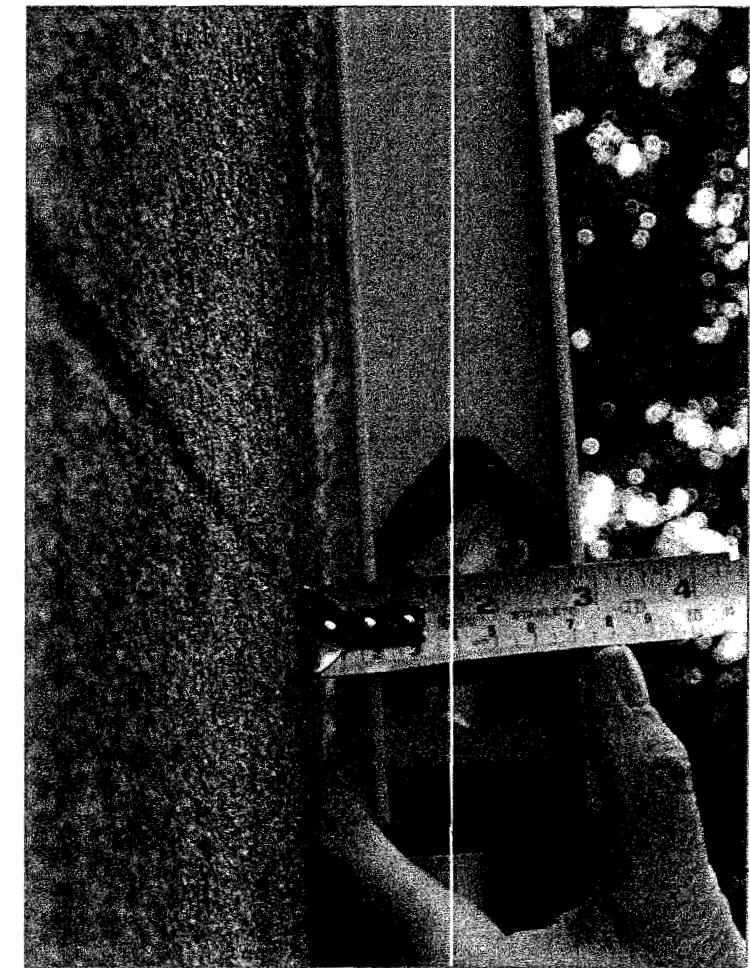
Vertical outward deflection of wall 17mm measured over 0.9m.
 Approx 131 mm displacement over height of wall.

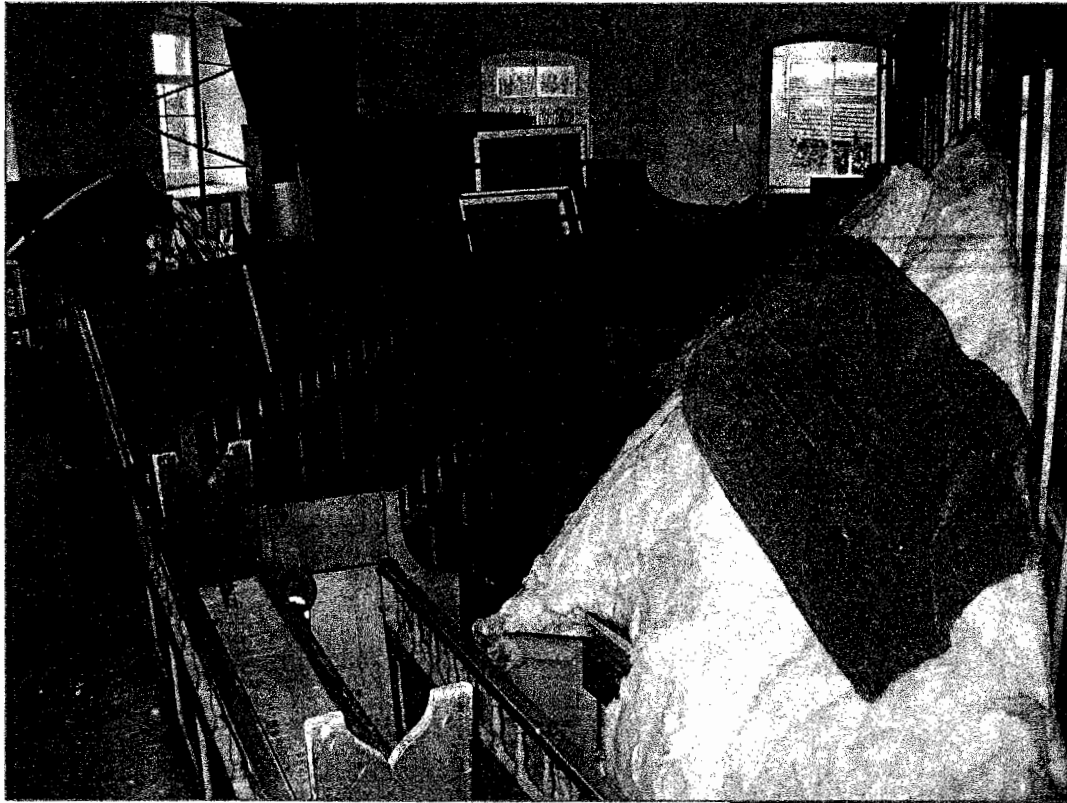
Existing redundant balcony

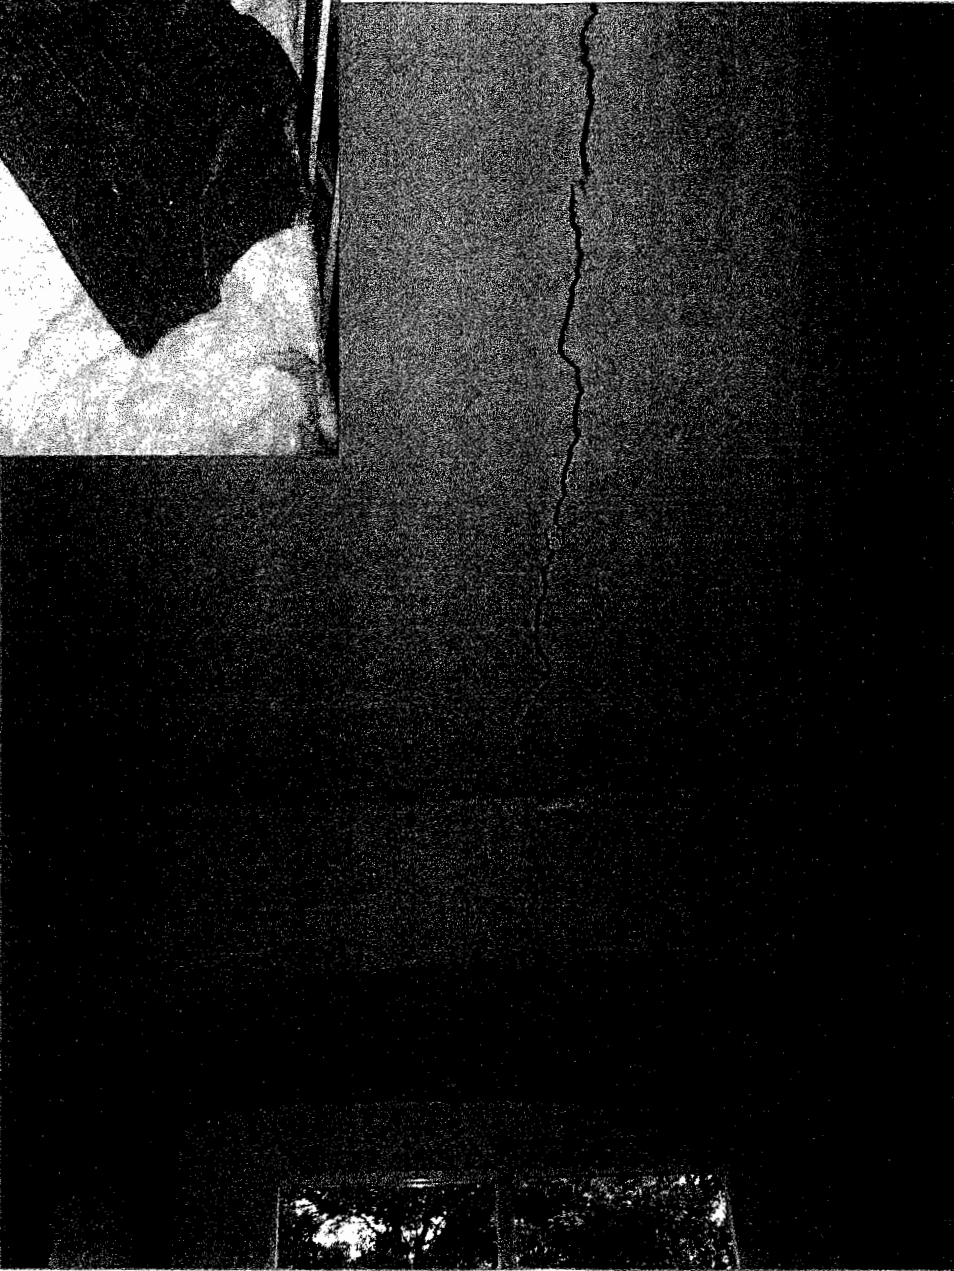
Structural crack through ceiling and window lintels following line of Truss over.

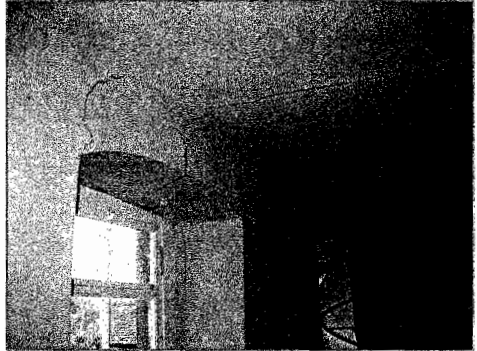
Multiple cracks through central window

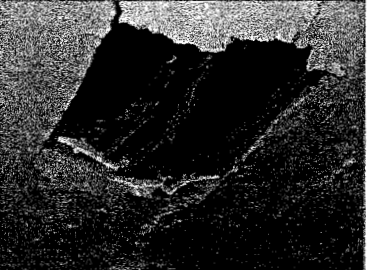
Failure of existing plaster lath ceiling and weakened ceiling rose

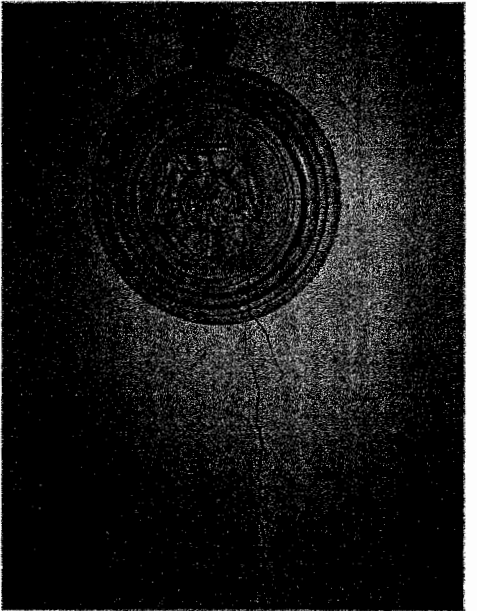
Major crack through to ceiling rose. Public danger from collapsing ceiling structure.

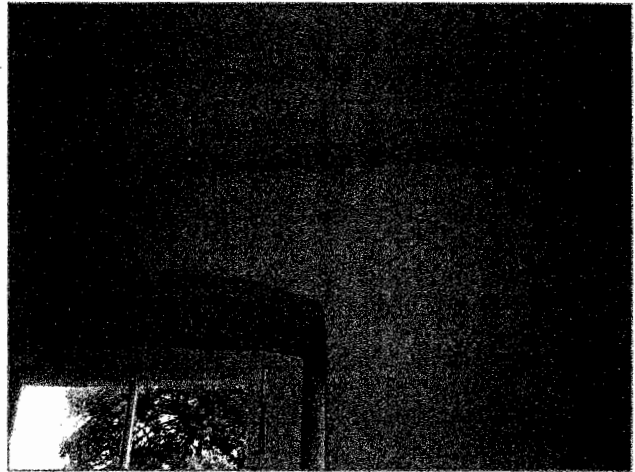
Multiple cracks through central window + lintels

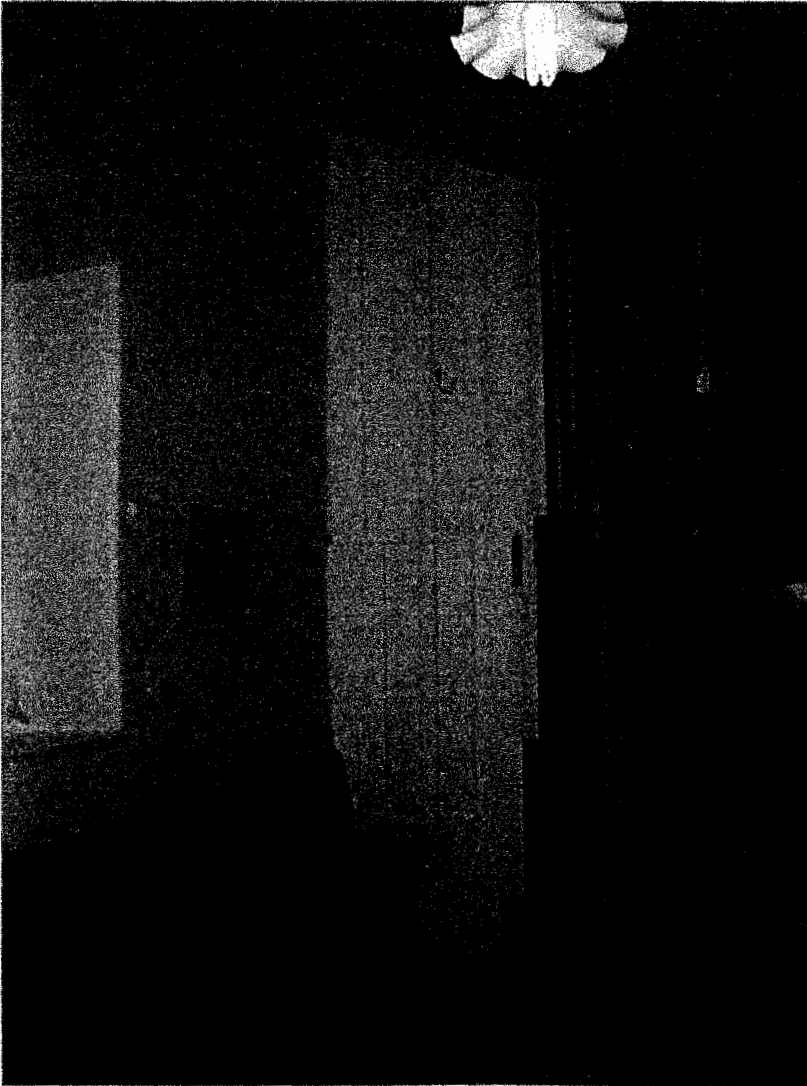
Rear Pews of Chapel - proposed site of buttress in Option A

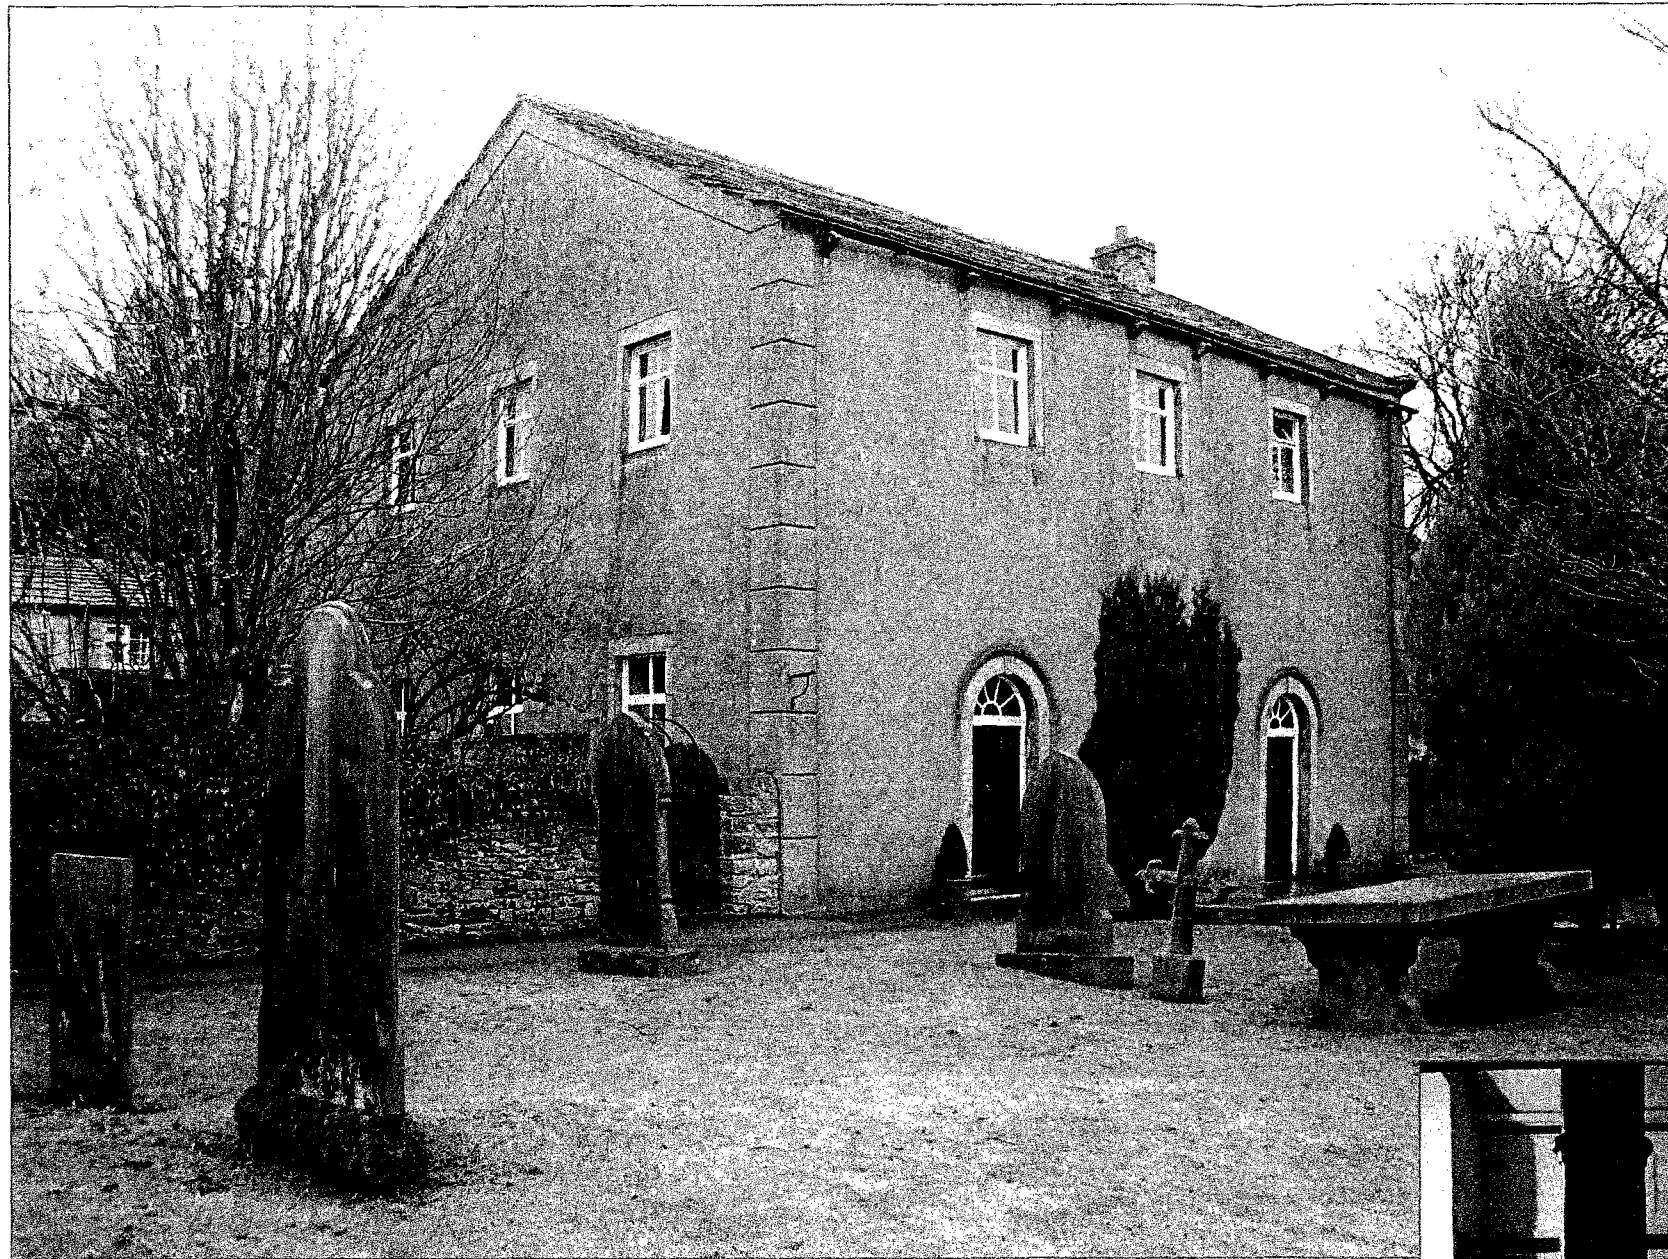
Garrs Lane Congregational Church
Grassington

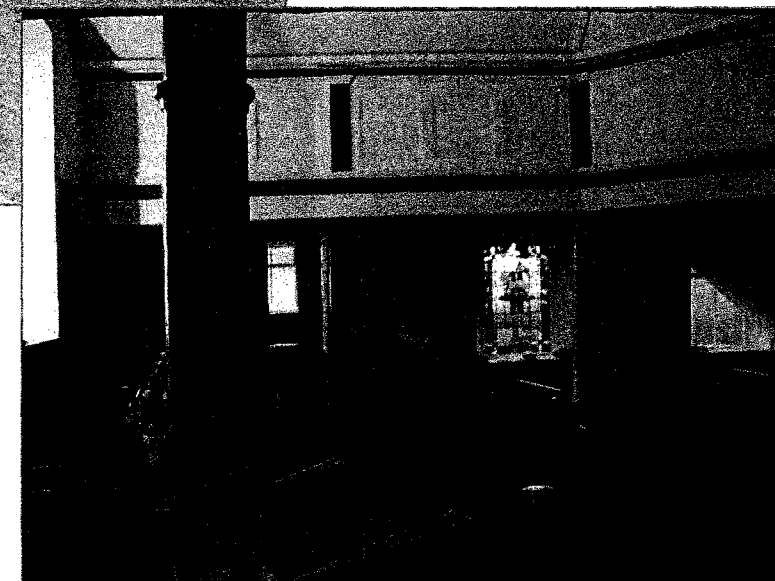
LISTED BUILDING CONSENT APPLICATION

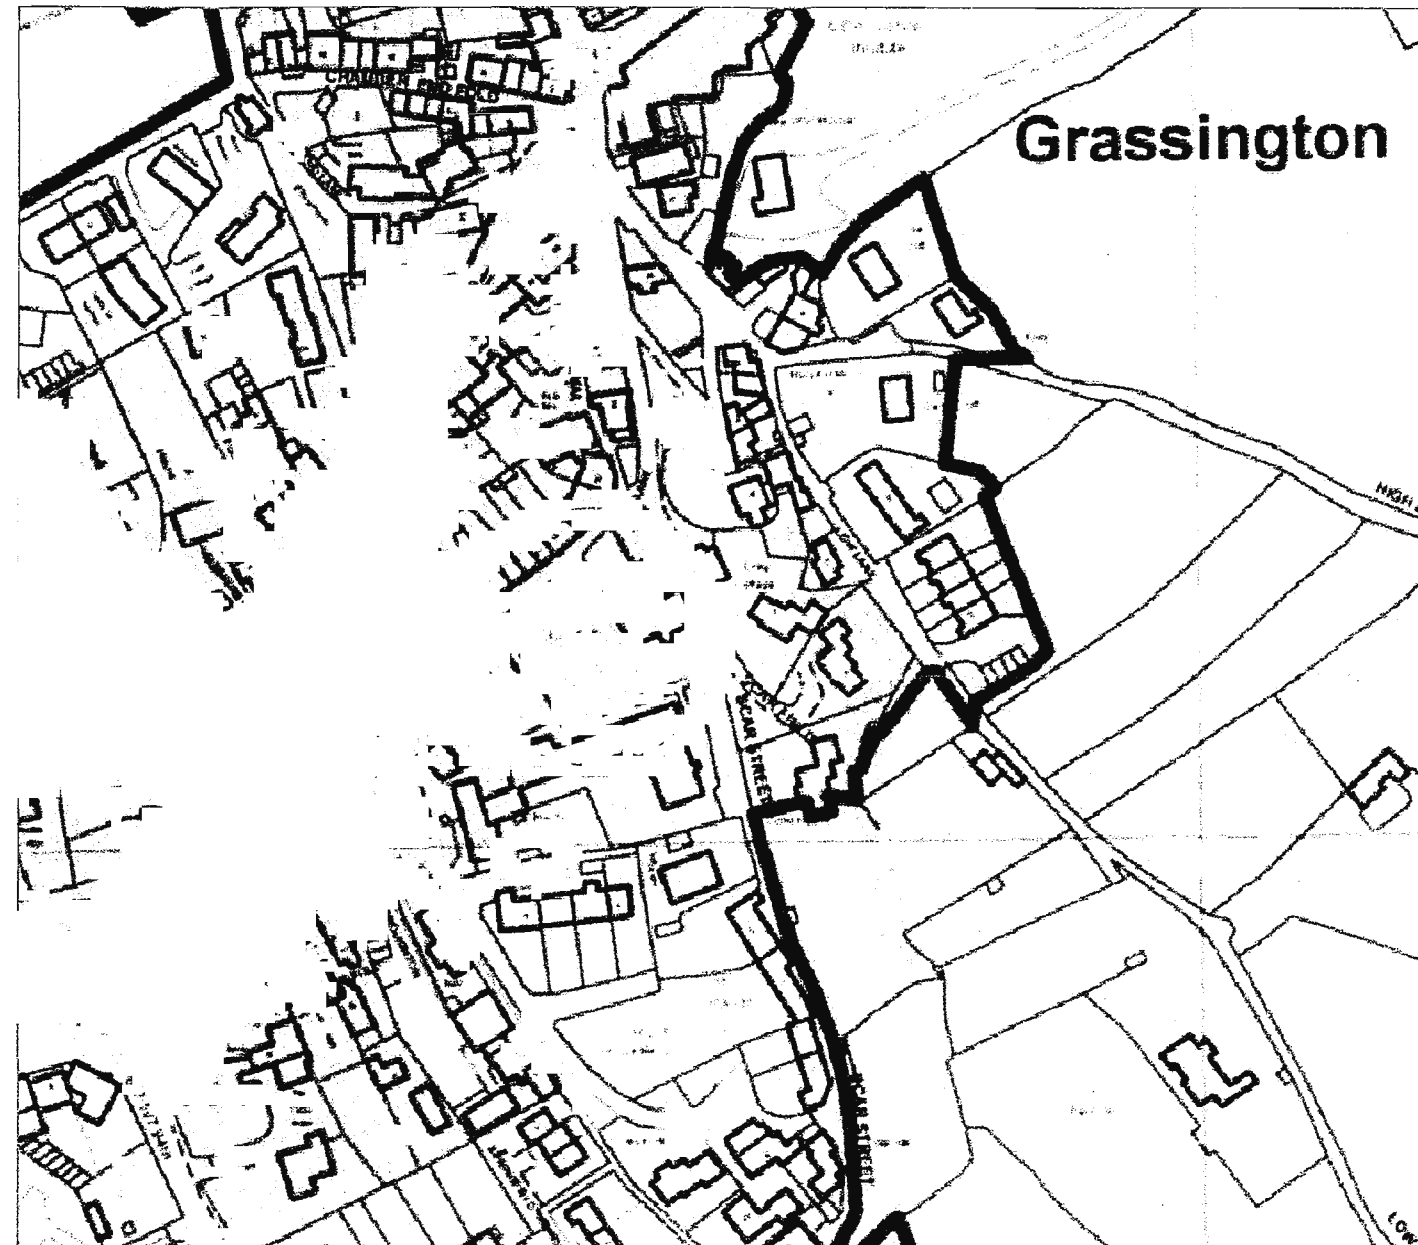
LISTED BUILDING CONSENT APPLICATION

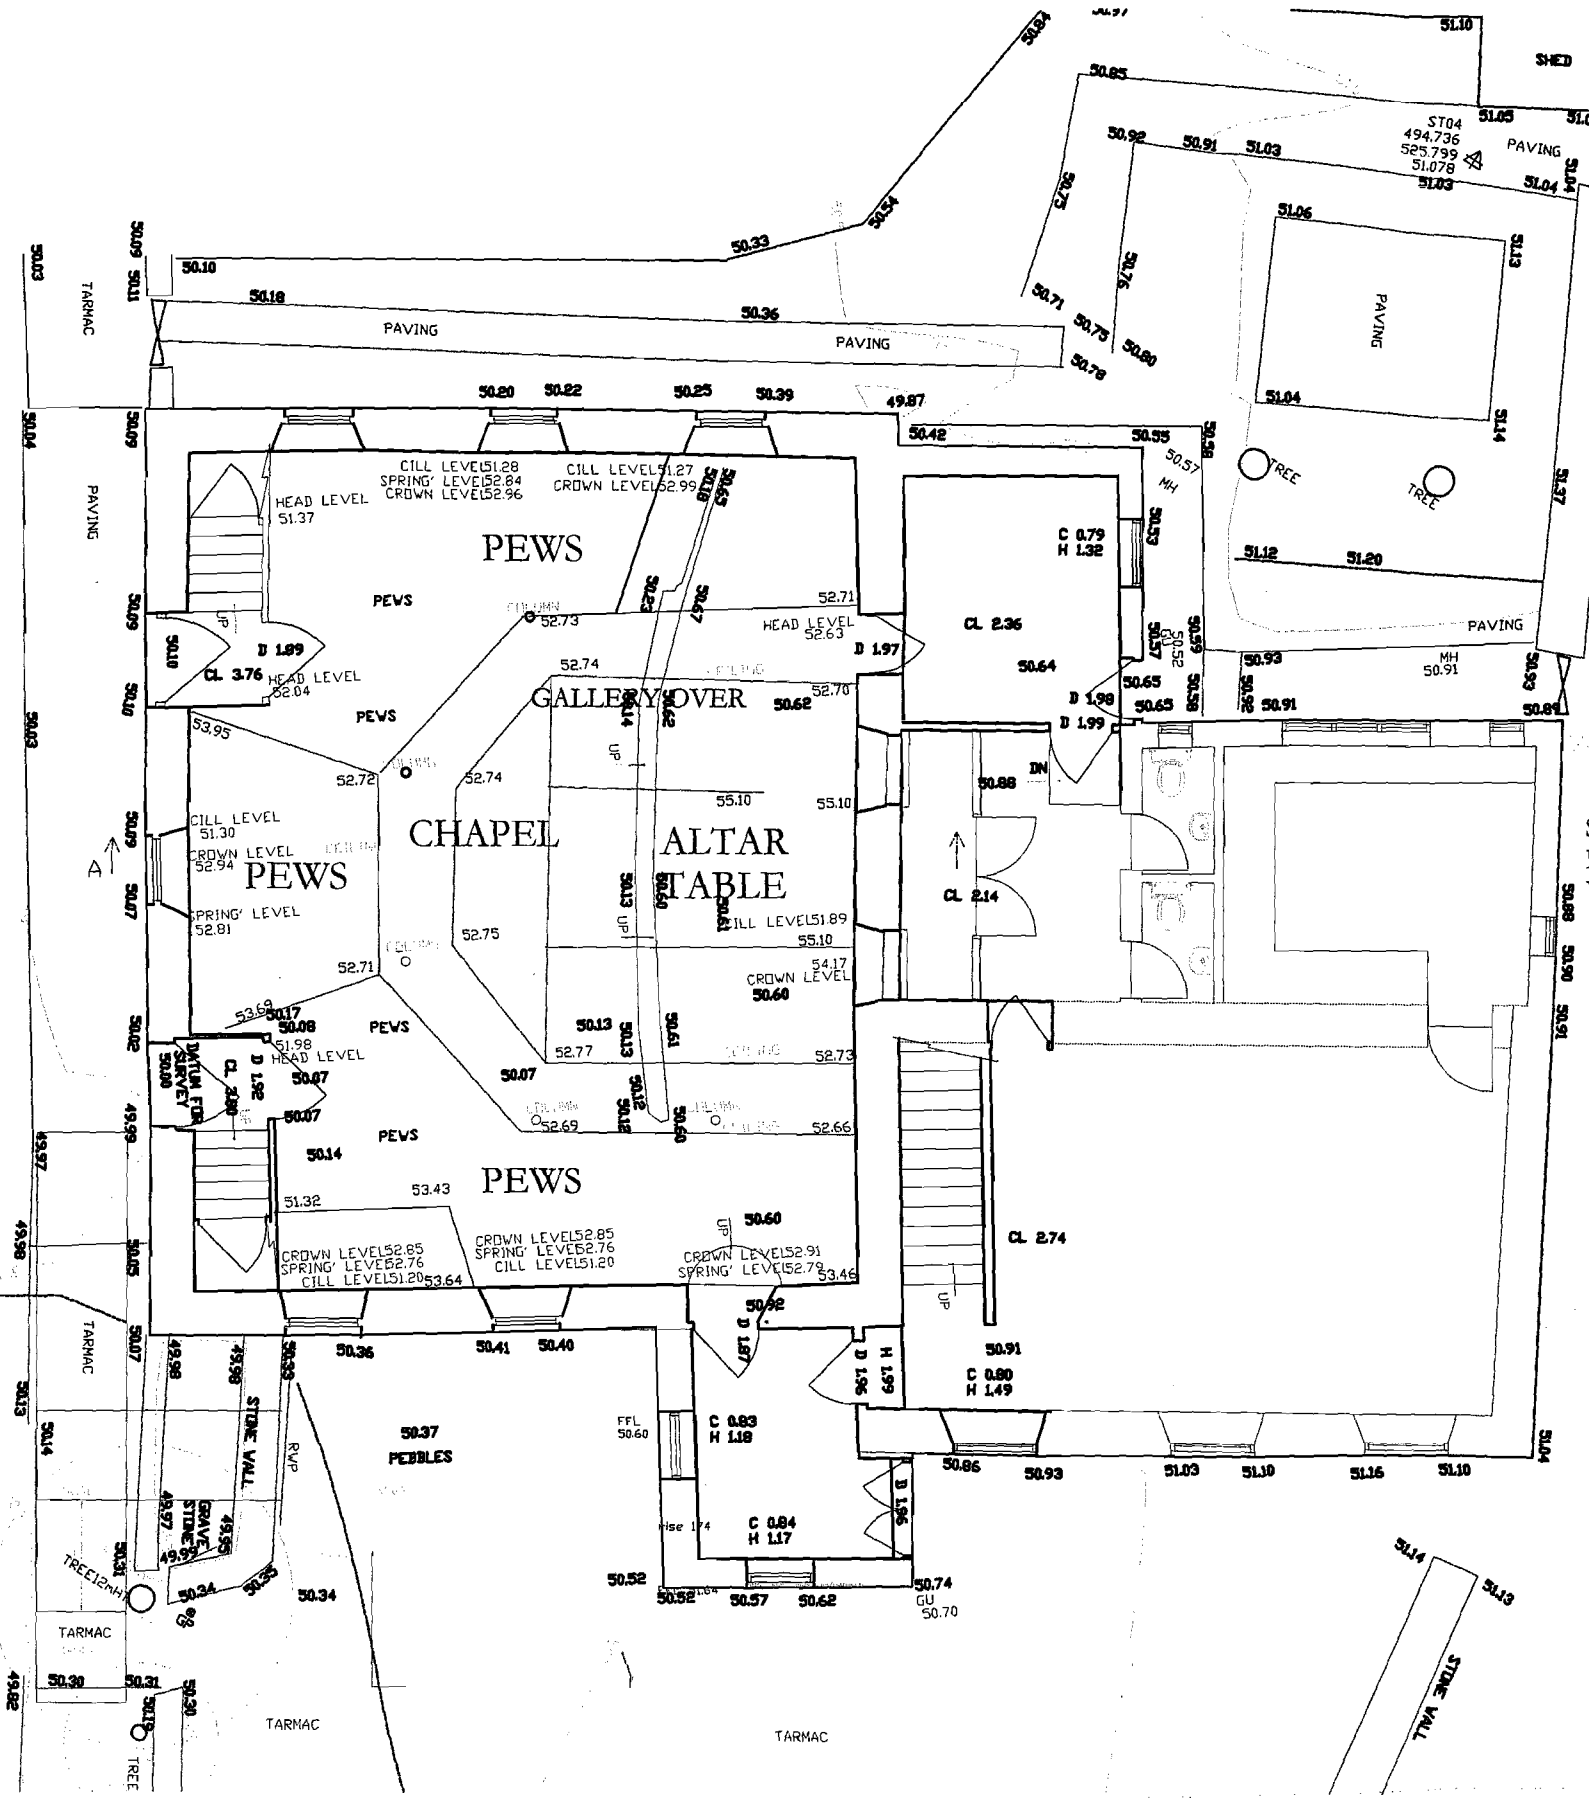
Ground Floor Plan (EXISTING) 1:100

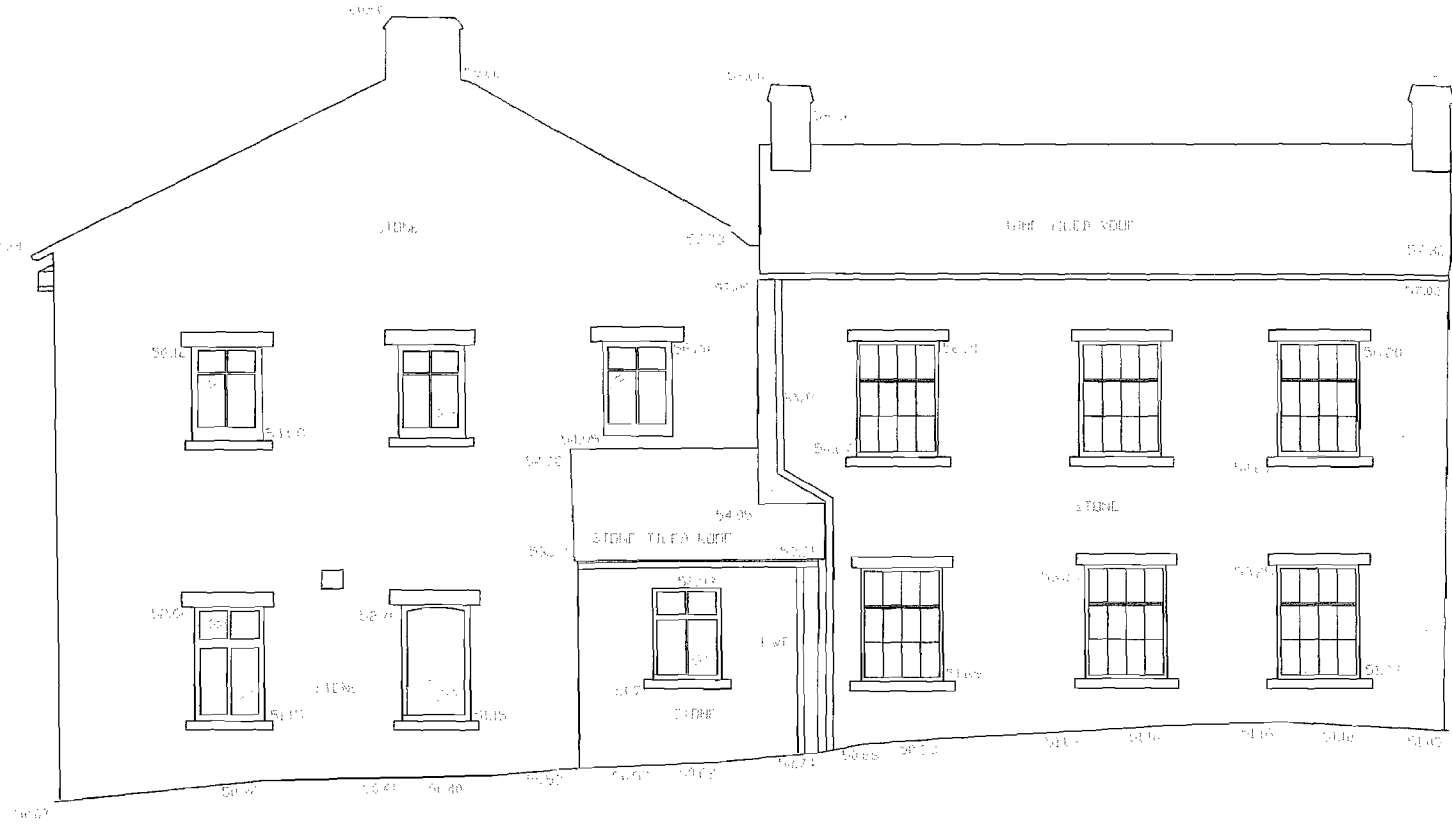
Side Elevation East (EXISTING) 1:100

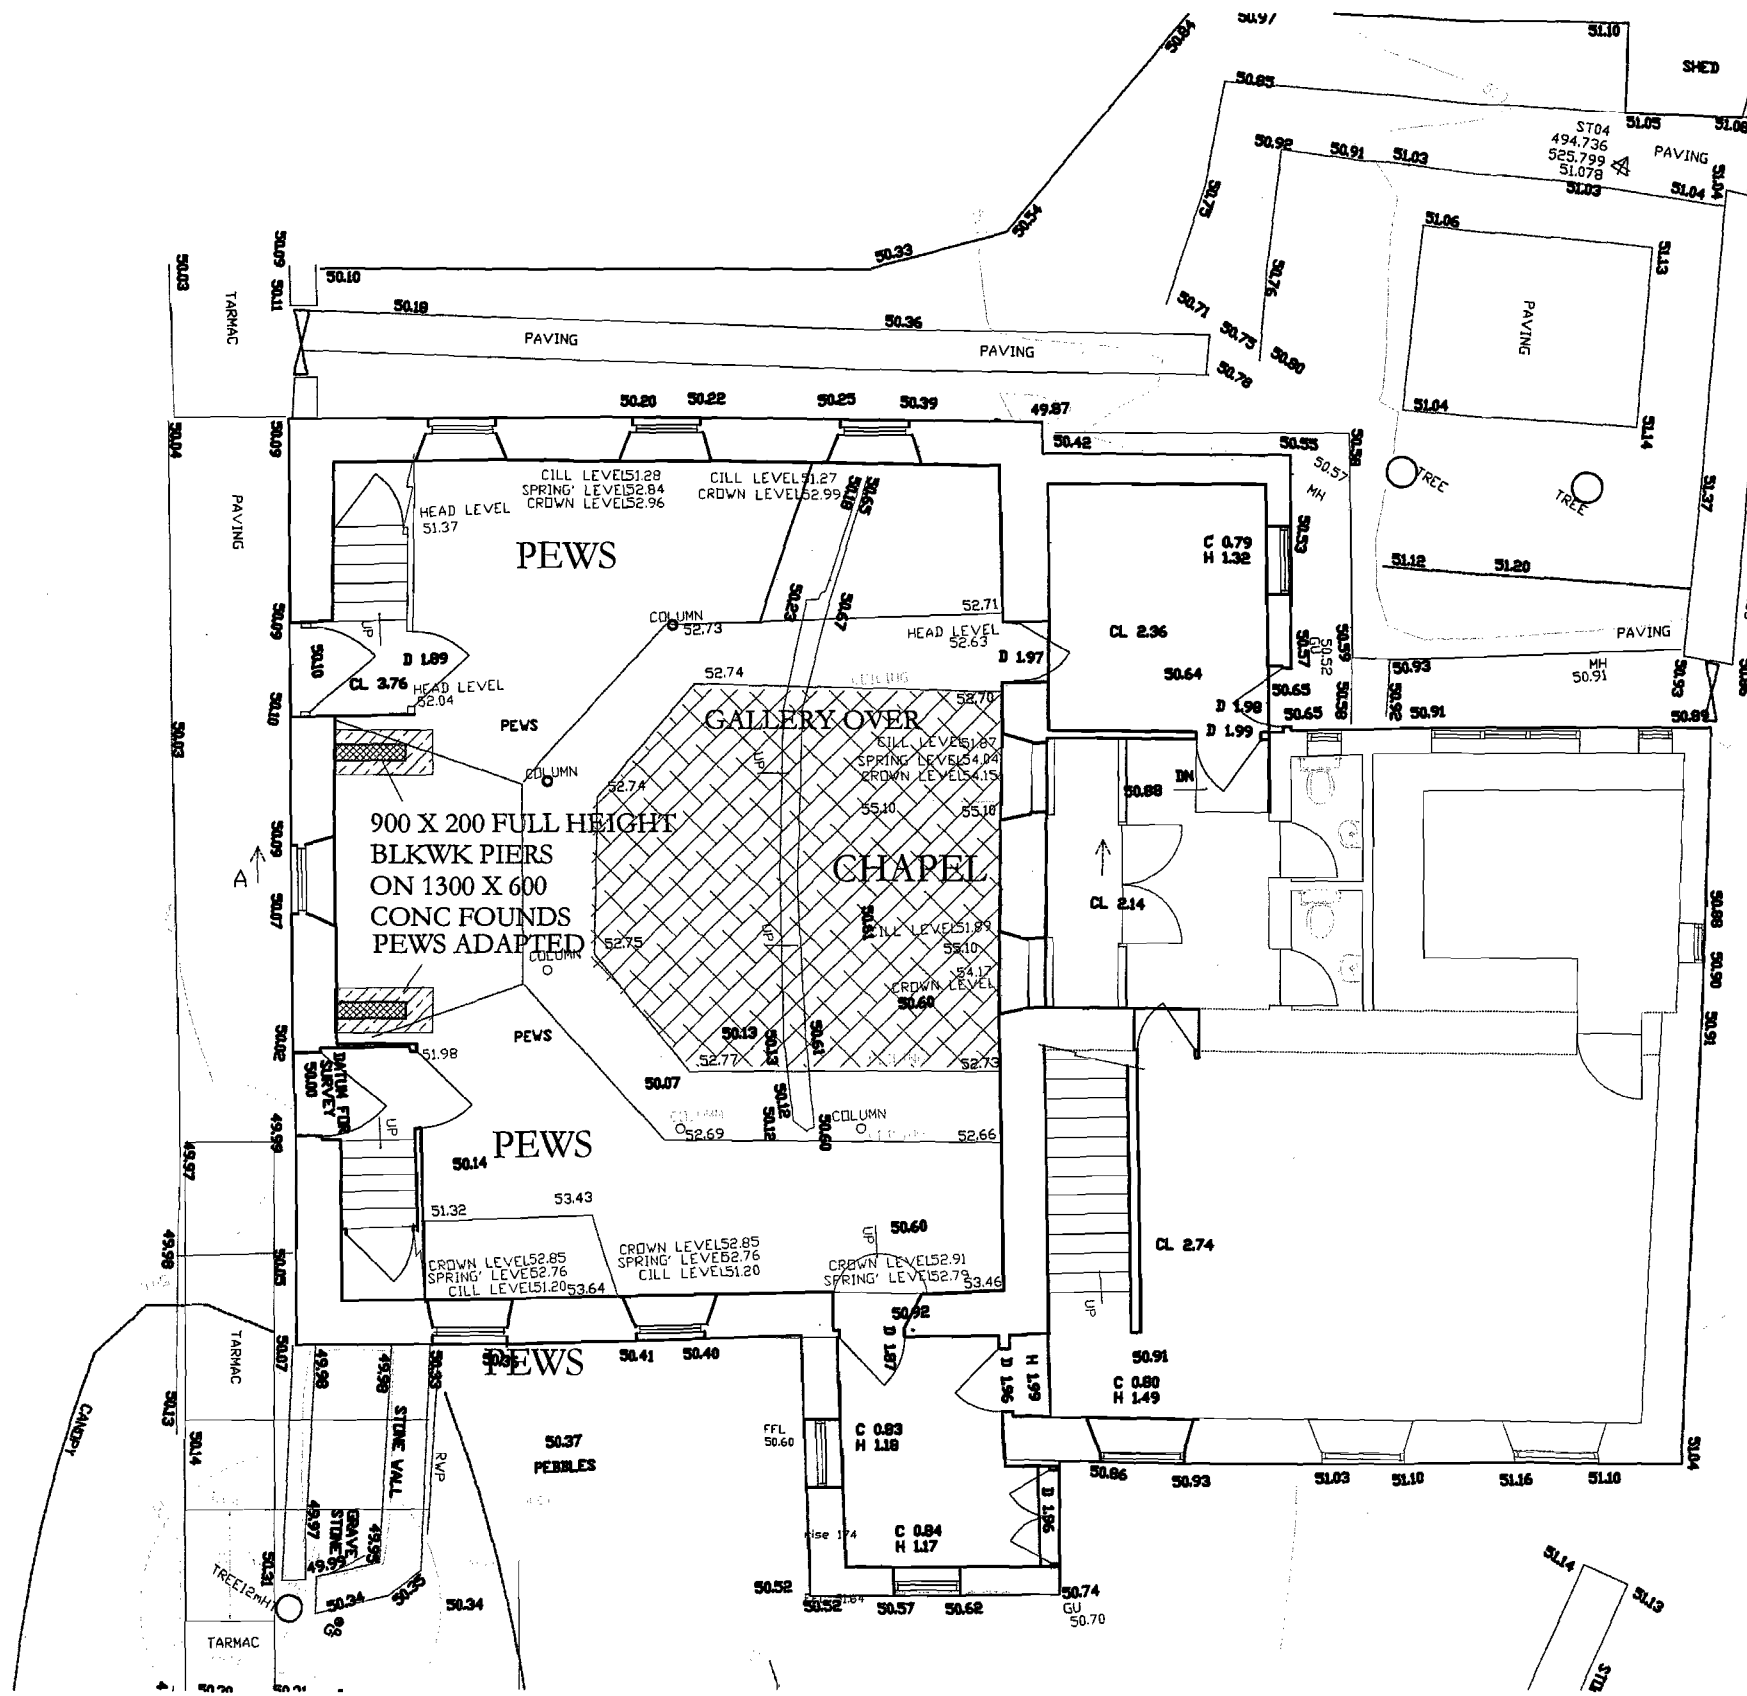
Ground Floor Plan (OPTION A) 1:100

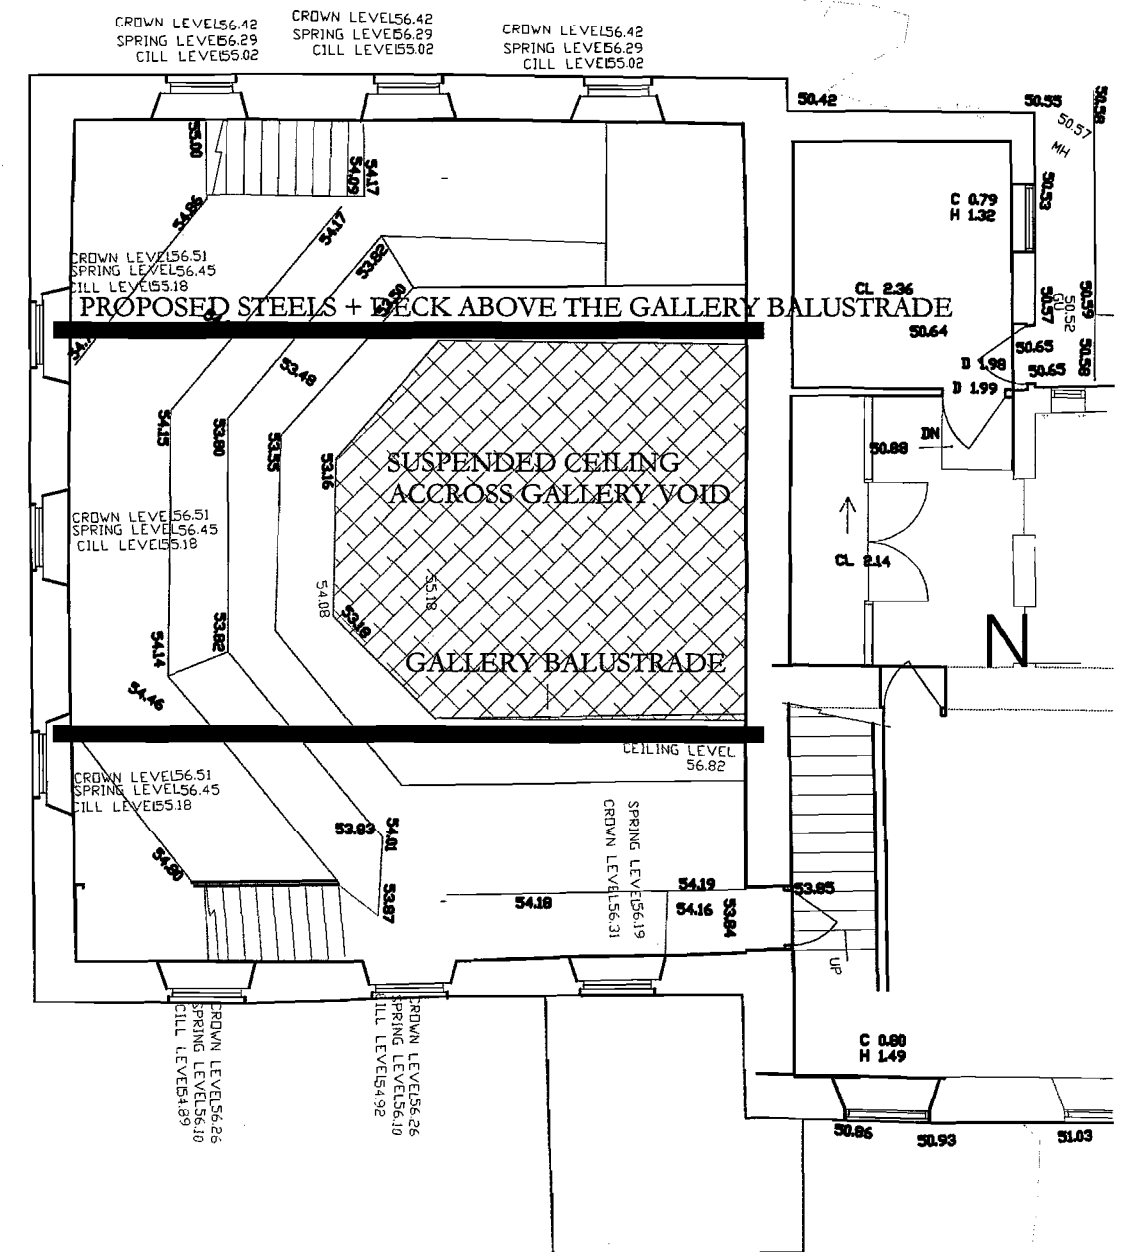
First Floor Plan (OPTION B) 1:100
LISTED BUILDING CONSENT APPLICATION
