YORKSHIRE DALES NATIONAL PARK AUTHORITY

Yoredale
Bainbridge
Leyburn
North Yorkshire
DL8 3EL
Tel: 0870 1 666333
Fax: 01969 652399
E-mail: planning@yorkshiredales.org.uk

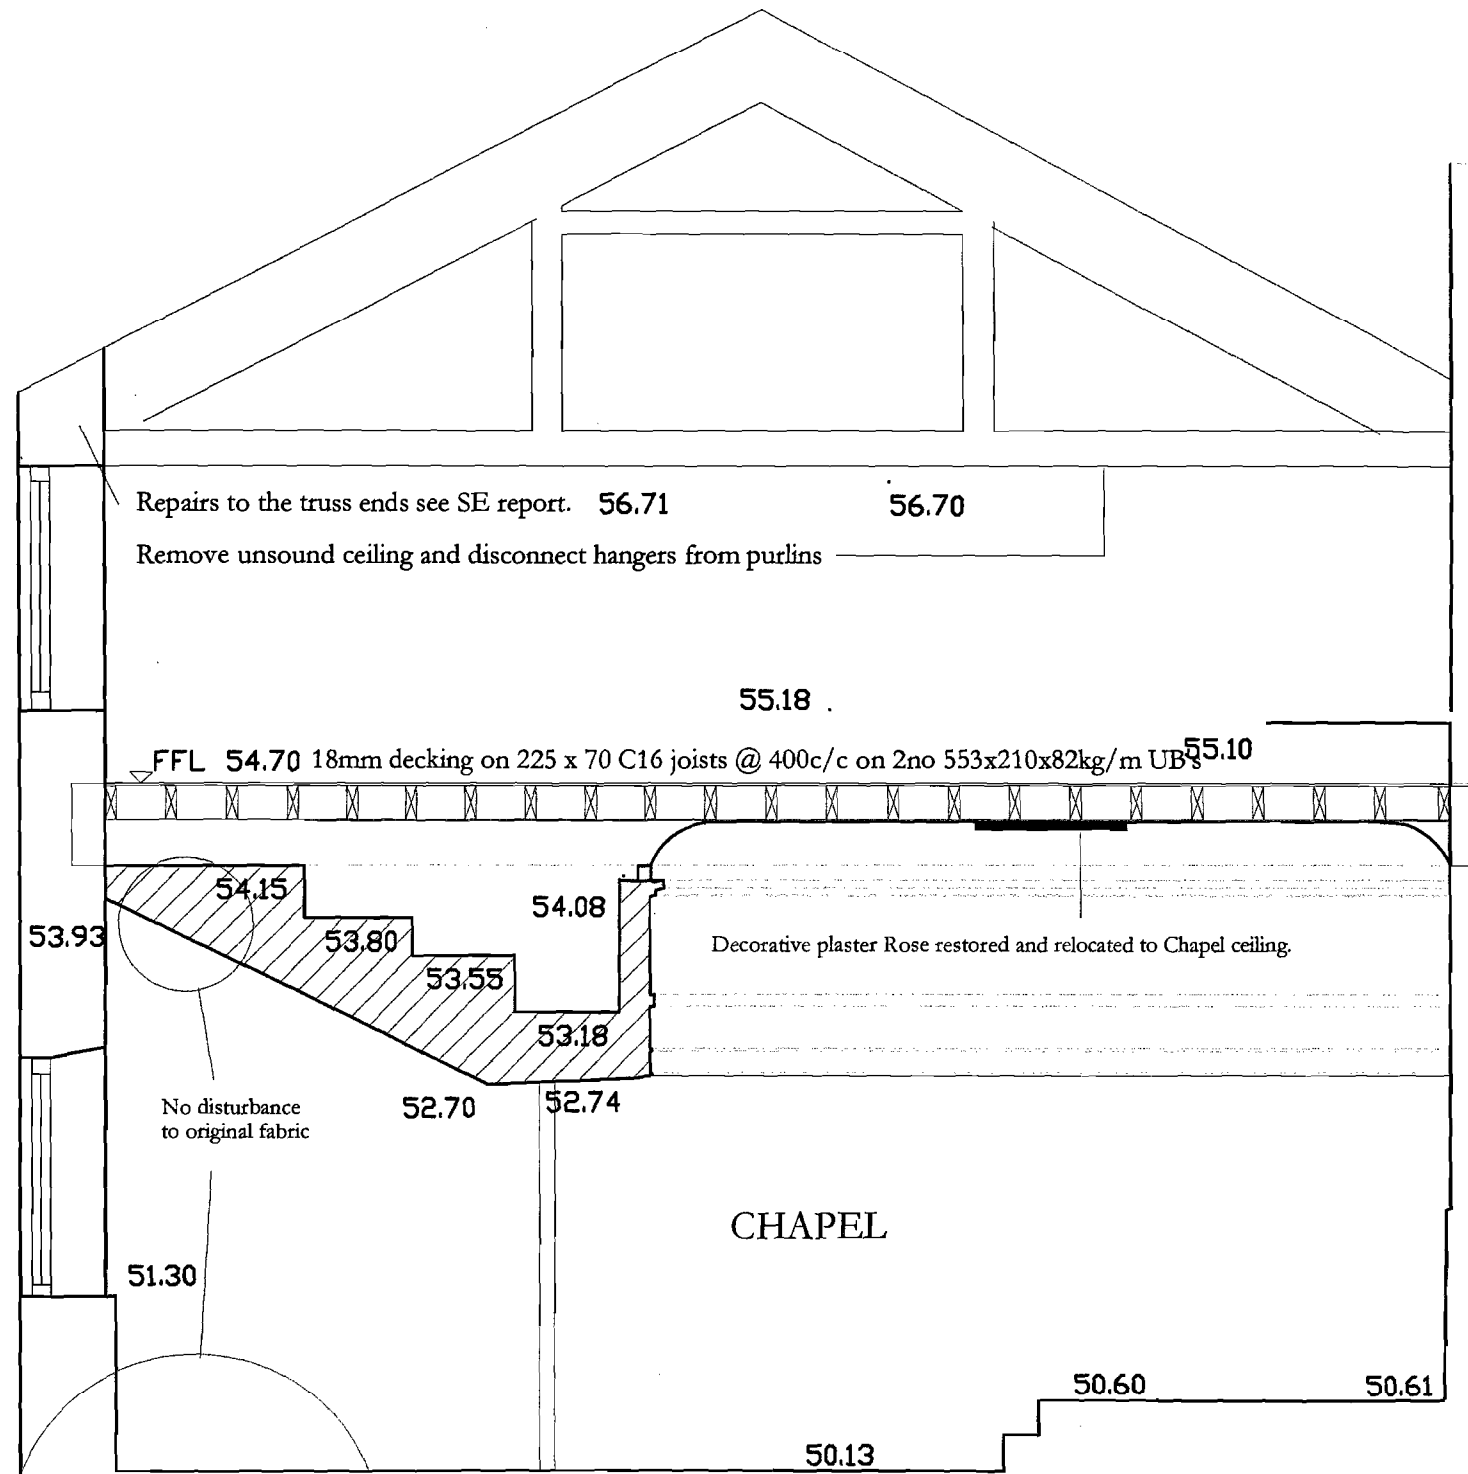
Section OPTION B - DECK BRACING
