**REPORT ON STRUCTURAL APPRAISAL
GARRS LANE CONGREGATIONAL CHRISTIAN CHURCH, GRASSINGTON**

Garrs Lane Christian Church
Grassington

Proposed First Floor Meeting Room,
Entrance and Stair Enclosures
and
Amenity Facilities

PLANNING APPLICATION + LISTED BUILDING CONSENT APPLICATION

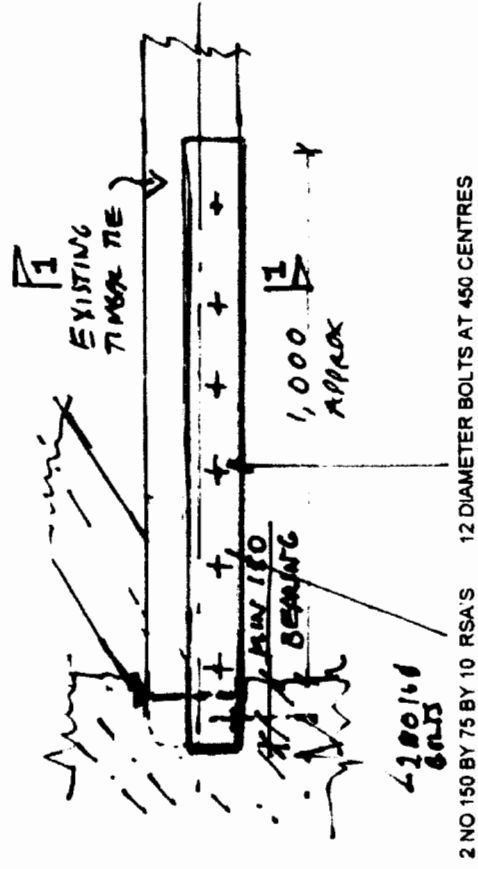
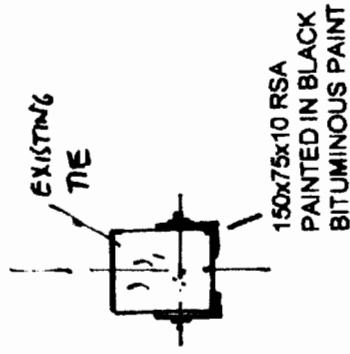
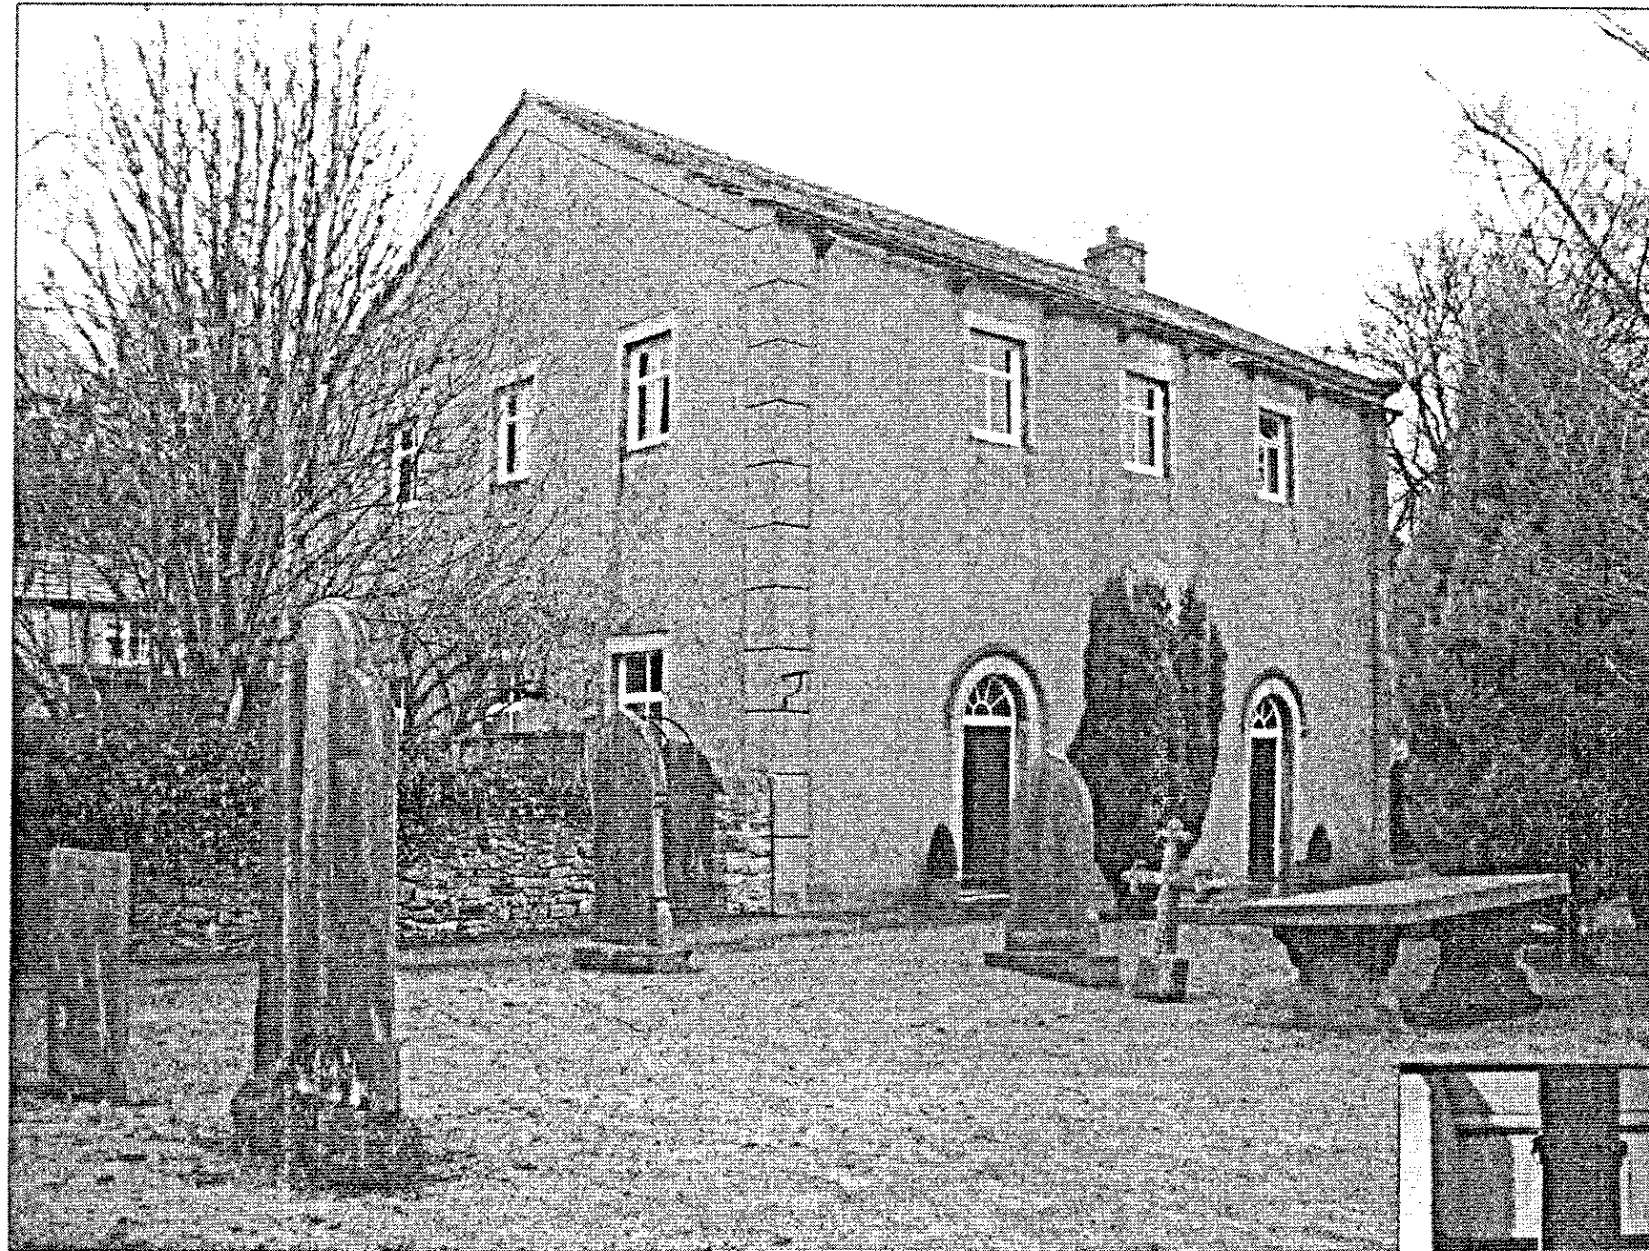
Sketch SK1 showing method of repair of ends of trusses

REPAIR OF END OF TRUSS TIE

ELEVATION OF TRUSS SHOWING REPAIR (1:20)

SECTION 1-1

5.1 We recommend that the walls be restrained at mid height by a new first floor structure with steel beams and timber joists. The steel beams should be properly tied into the walls. The cracks in the walls should be repaired with appropriate matching mortar and joints repointed as necessary. The ends of the trusses and ends of timber purins in exposed walls should be checked for wood rot and repaired if necessary. However in any case the ends of timber trusses should be properly connected to the walls with steel angles (see sketch SK1 in the appendix).

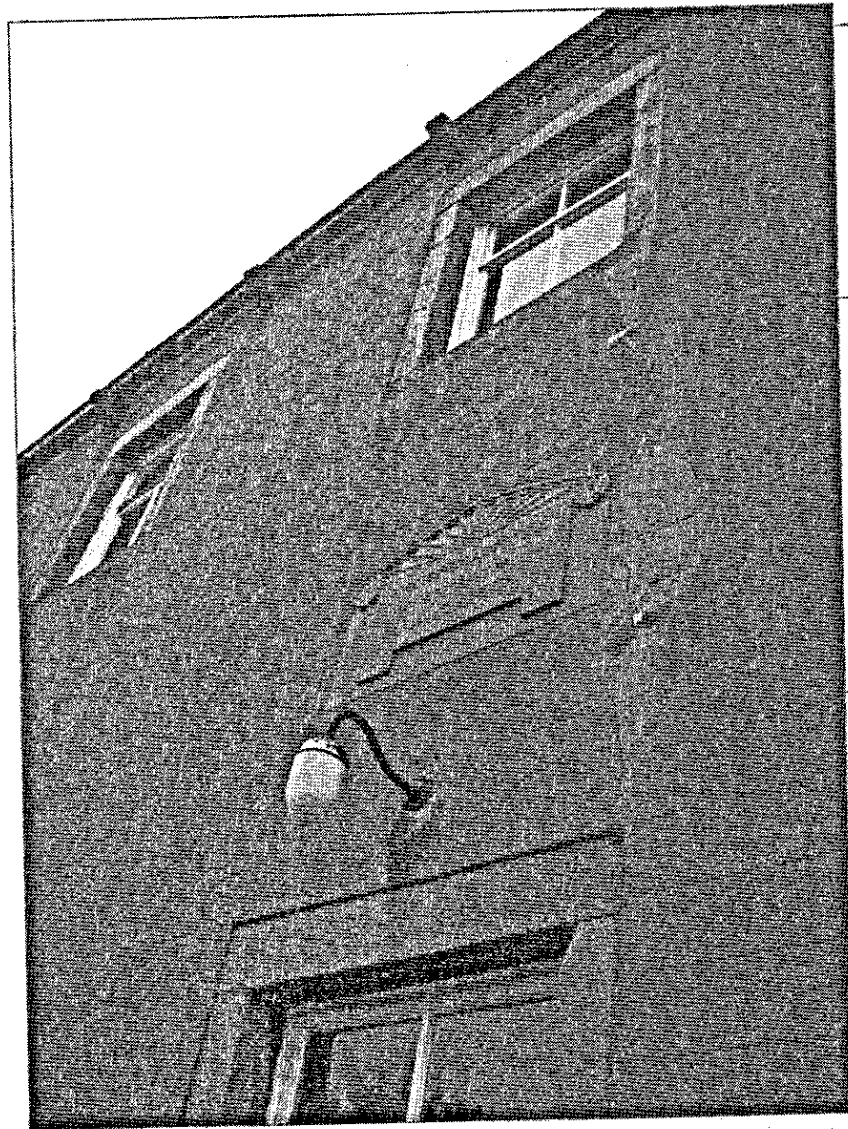
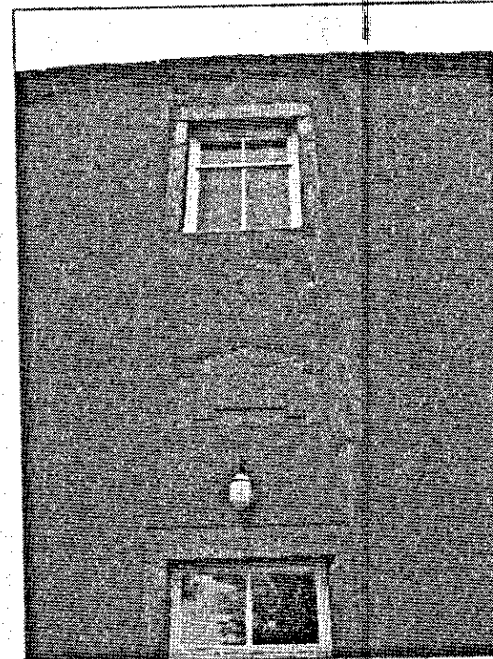
Cracks through external wall

Movement in the building resulting from generally poor construction has lead to cracks appearing to the main front wall (south west) . The spread of the roof against an unrestrained front wall has lead to cracking throughout the height of the chapel wall and through to the gable walls. The original design of central windows has further weakened the structural integrity of the front wall. The building, although relatively stable, presents a serious risk of partial collapse of the roof and front wall. It represents an unpredictable and considerable danger to the public. These cracks are cause for concern and although relatively stable, do indicate a structural failing within the fabric. This is covered in more detail by the Structural Engineers Report enclosed with the application.

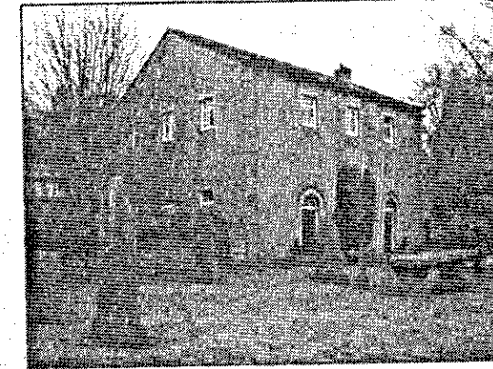
Chapel elevation (west) indicating wall bowing following outward roof thrust

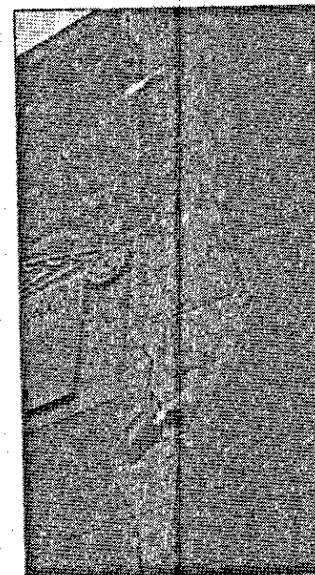
Vertical outward deflection of wall 17mm measured over 0.9m.
Approx 131 mm displacement over height of wall.

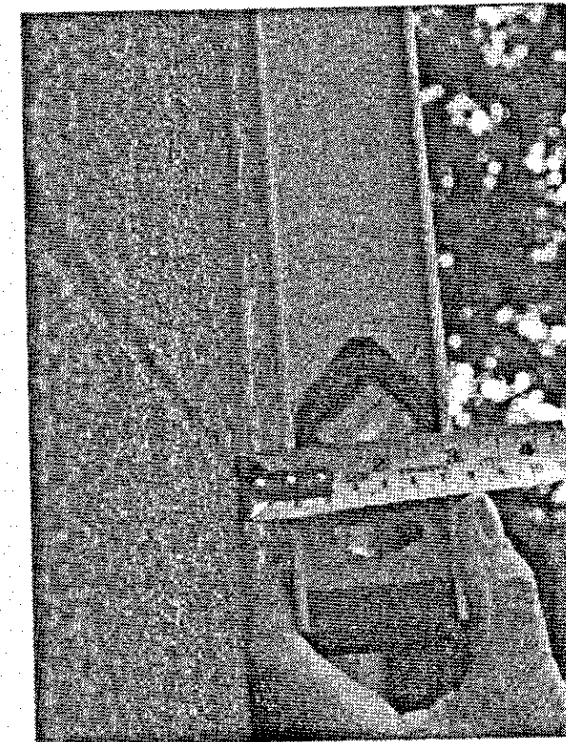
Vertical cracks through external wall either side of ground and first floor windows. They result from outward thrusts of roof trusses against solid two storey masonry weakened by the introduction of central window openings. The structural failure could further weaken the wall and lead to a serious danger to members of the public.

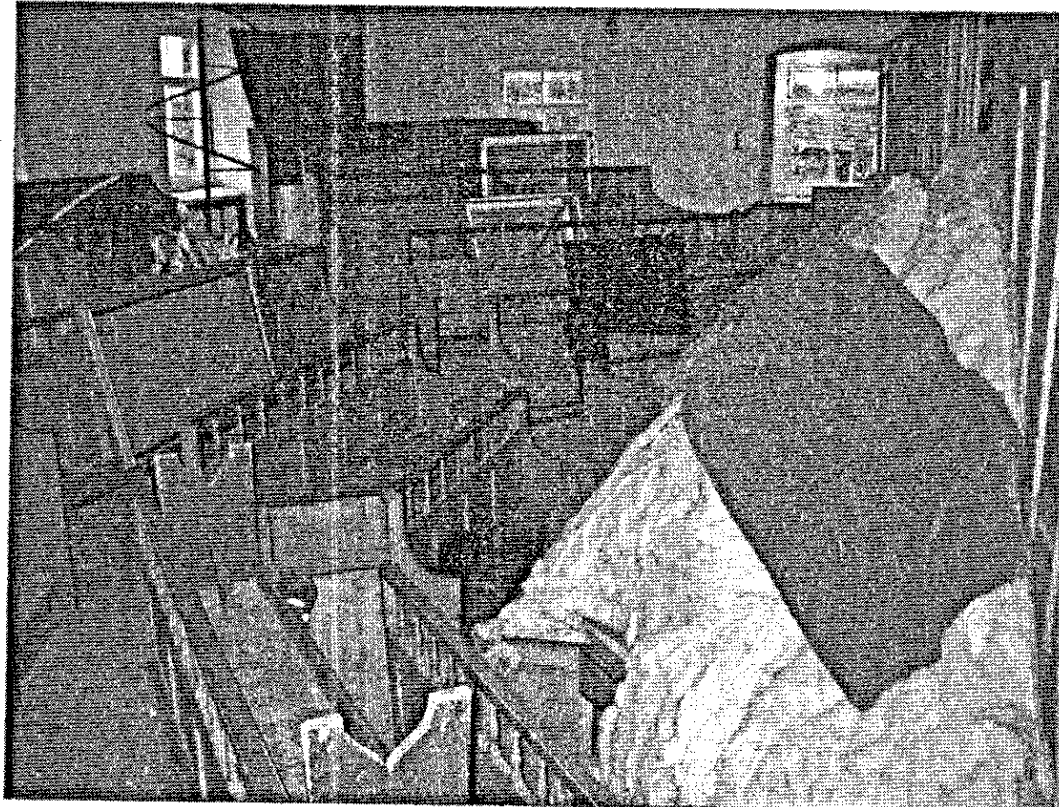
Existing redundant balcony

The proposed floor is to be located at a level where it spans over the existing balcony floor and handrail of the balustrade. The face of the balustrade will then be retained on view from the chapel and with a slight 'negative' joint between that and the soffit of the new floor. It is proposed that the original balcony seating be stored within the floor zone and the redundant stair enclosures, thus preserving them on site for posterity.

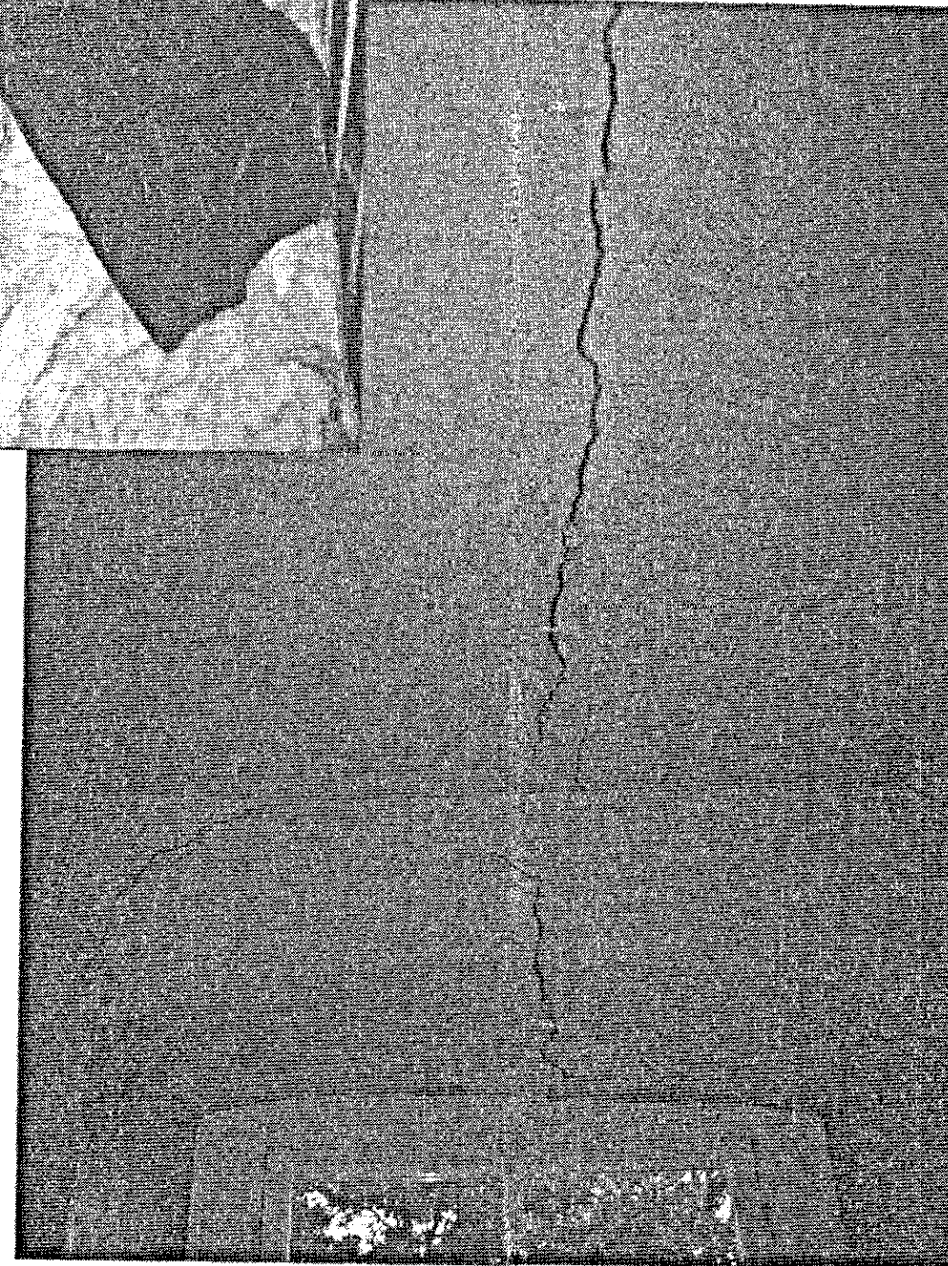
Structural crack through ceiling and window lintols following line of Truss over.

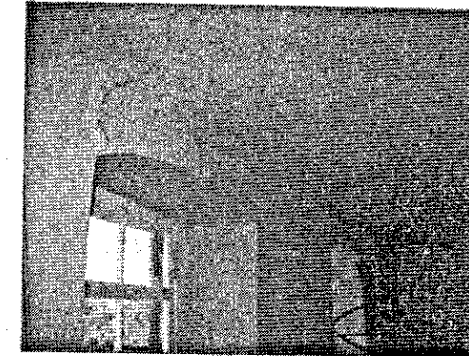
Multiple cracks through central window

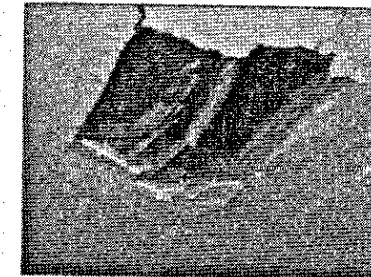
Failure of existing plaster lath ceiling and weakened ceiling rose

The lath and plaster ceiling of the balcony is sagging and considerably decayed. It is proposed to take this down and open up the space to the roof, which has already been reslated and to be underdrawn with insulation and plasterboard. The trusses, fine Queen Posts would then be exposed. The decorative plaster Ceiling Rose would be carefully restored and resited possibly in the soffit of the new floor above the balcony well.

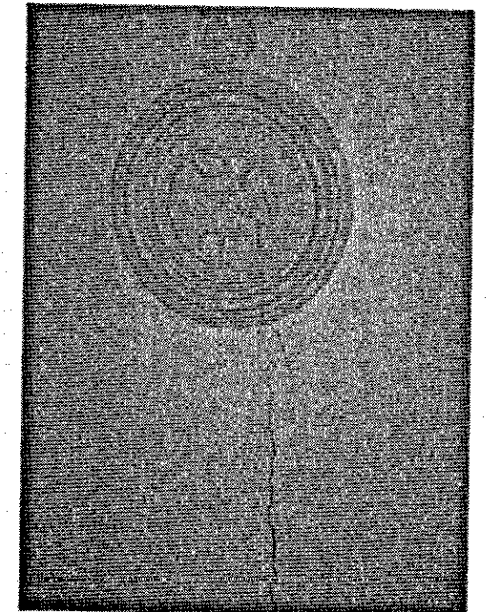
Major crack through to ceiling rose. Public danger from collapsing ceiling structure.

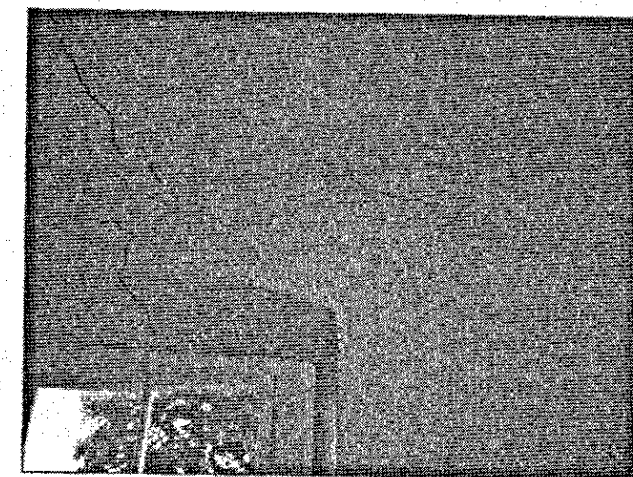
Multiple cracks through central window + lintols

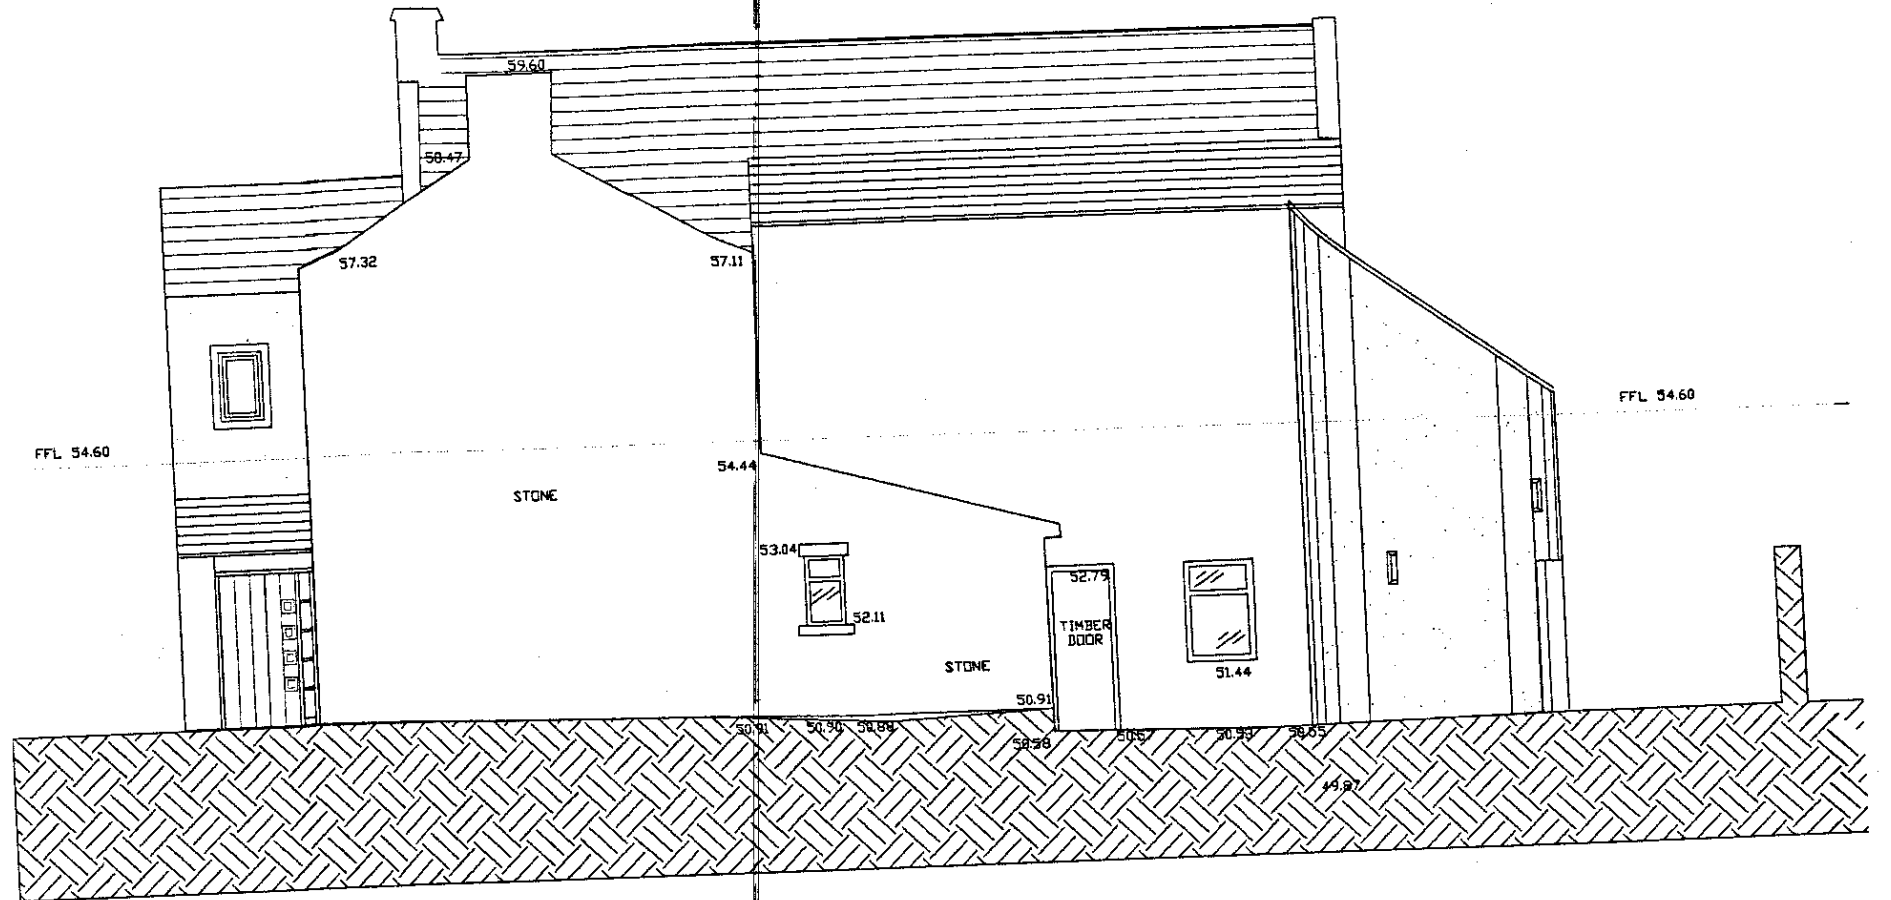
North East Elevation (PROPOSED) 1:100

PLANNING APPLICATION + LISTED BUILDING CONSENT APPLICATION
Rev A 13.08.07 omit first floor windows to north east elevation
